FIELD INVESTIGATION SURVEY OF
AIR TIGHTNESS, AIR MOVEMENT
AND INDOOR AIR QUALITY IN
HIGH-RISE APARTMENT BUILDINGS
ATLANTIC REGION

E.W. Scott Bennett, P. Eng.
BFL Consultants Limited
P.O. Box 12070
St. John's, Newfoundland
A1B 3T5

BFL Reference No.: 600-01

Date: 1991 04 30

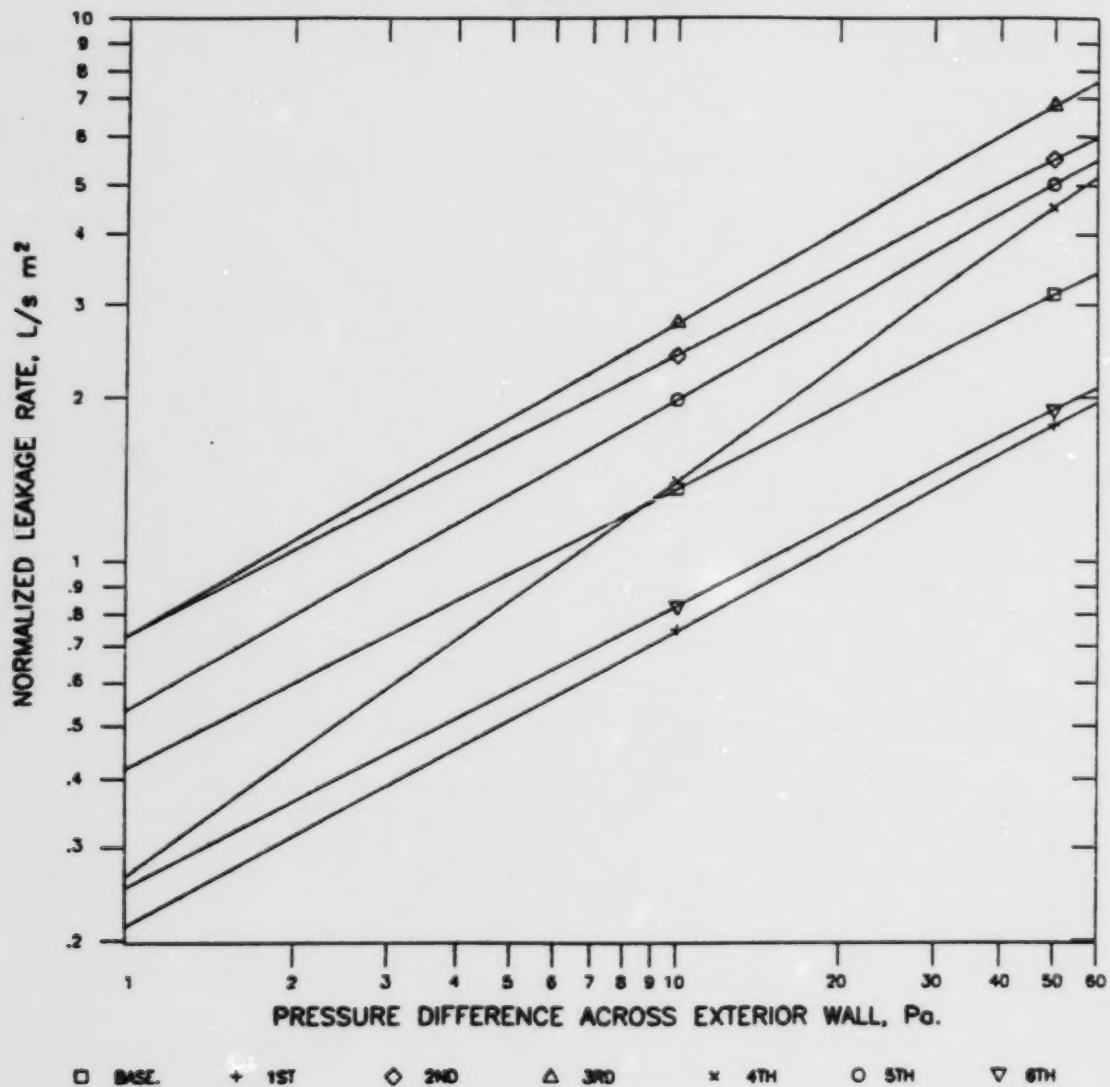
FIGURE 22: AIR TIGHTNESS OF EXTERIOR WALLS VARIES FROM FLOOR TO FLOOR.

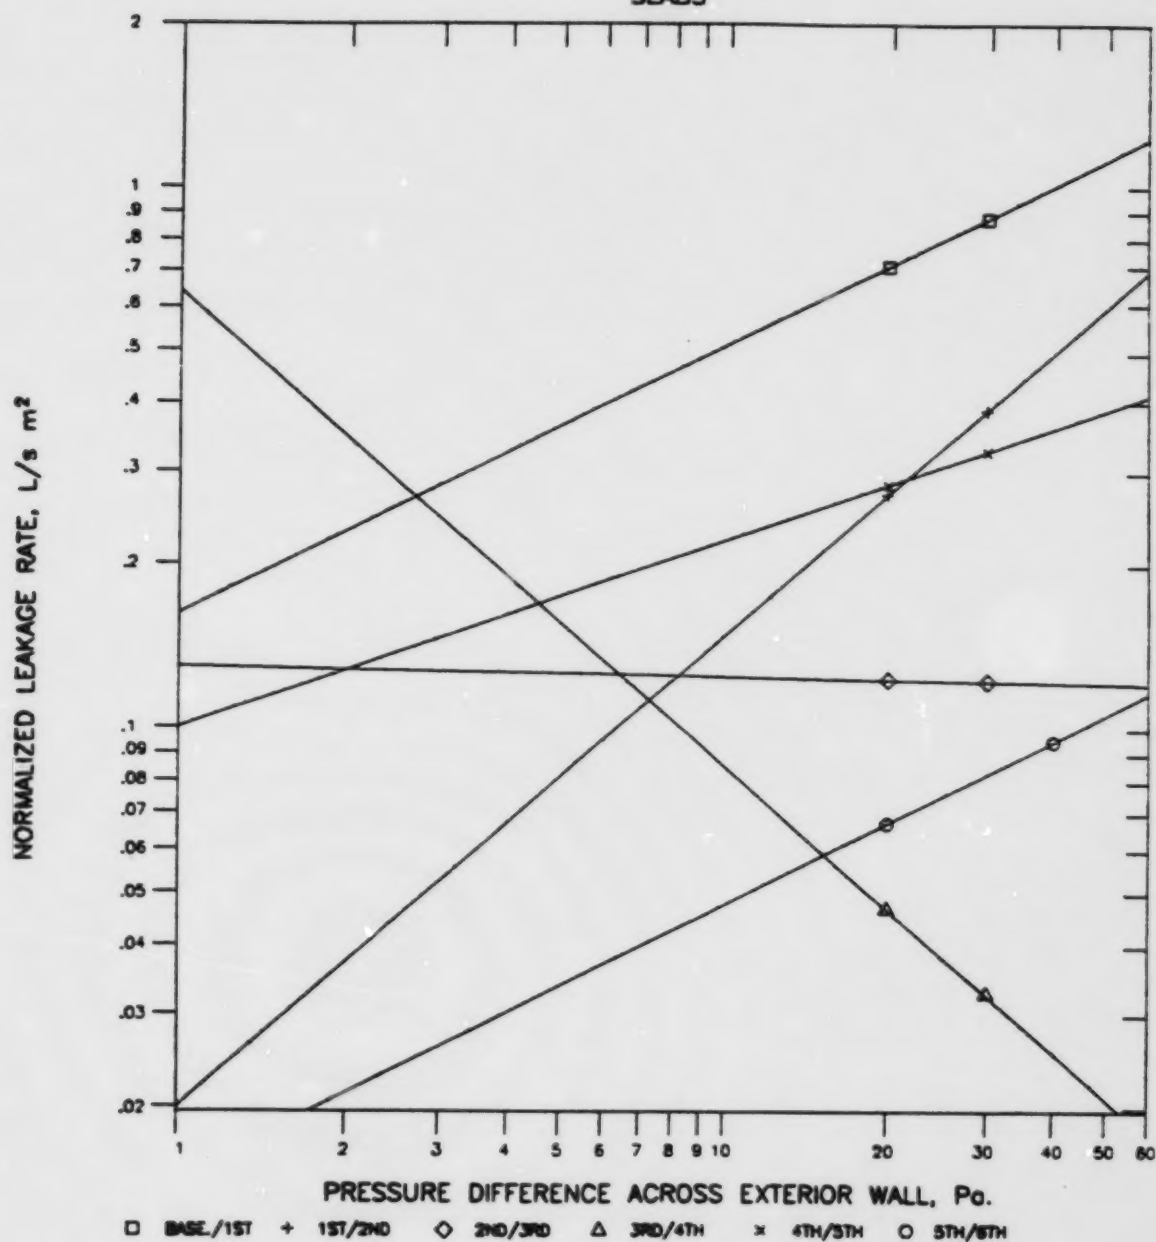
FIGURE 23: THE VARIABILITY OF THE FLOWS THROUGH THE SLABS IS CLEARLY DEMONSTRATED HERE. THE PROBLEM WITH THE 3RD STOREY'S SLABS ALSO BECOMES EVIDENT.

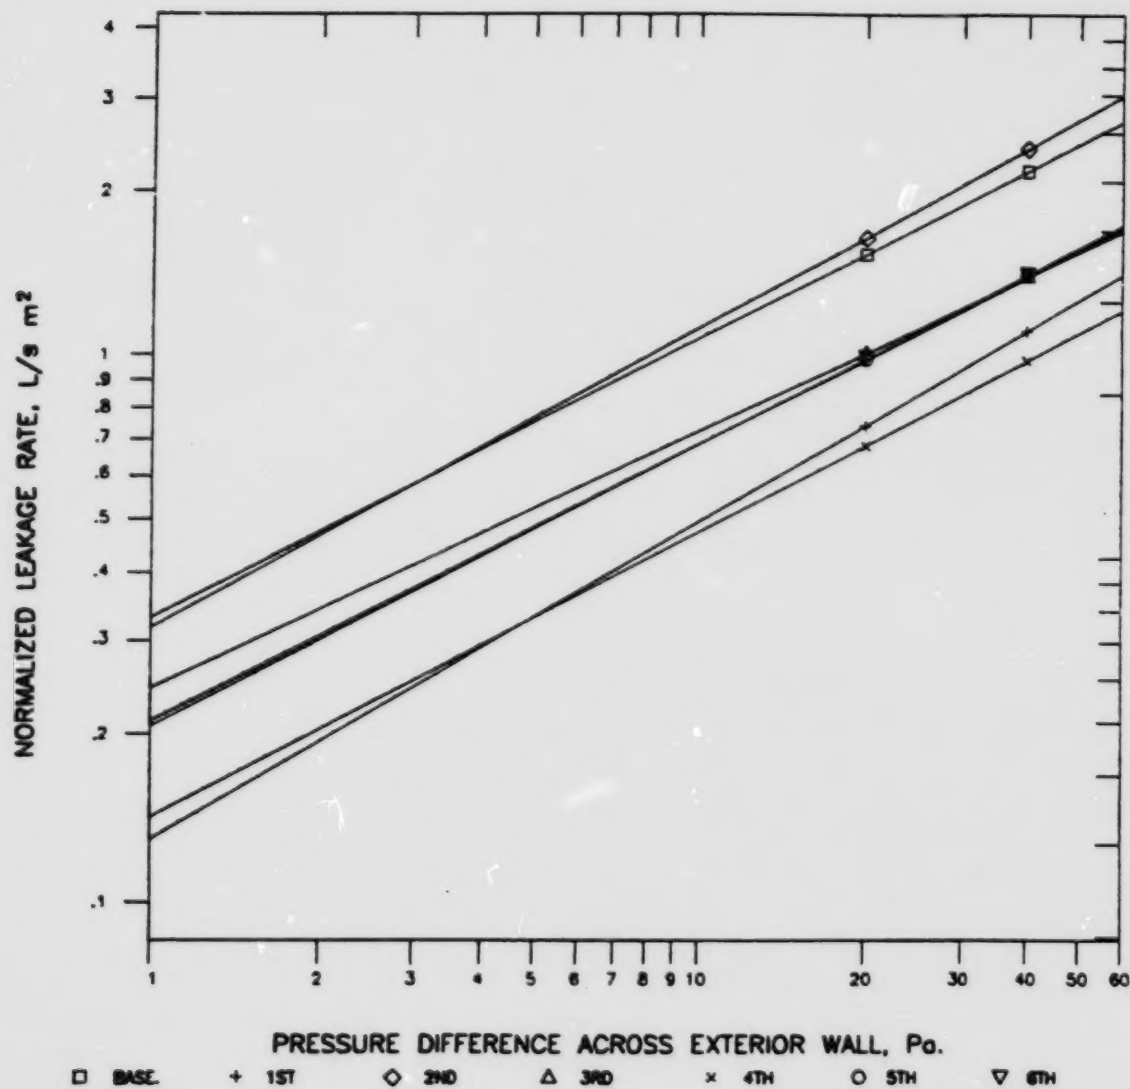
FIGURE 24: THERE IS A GREAT VARIANCE OF LEAKAGE RATE BETWEEN THE FLOORS.

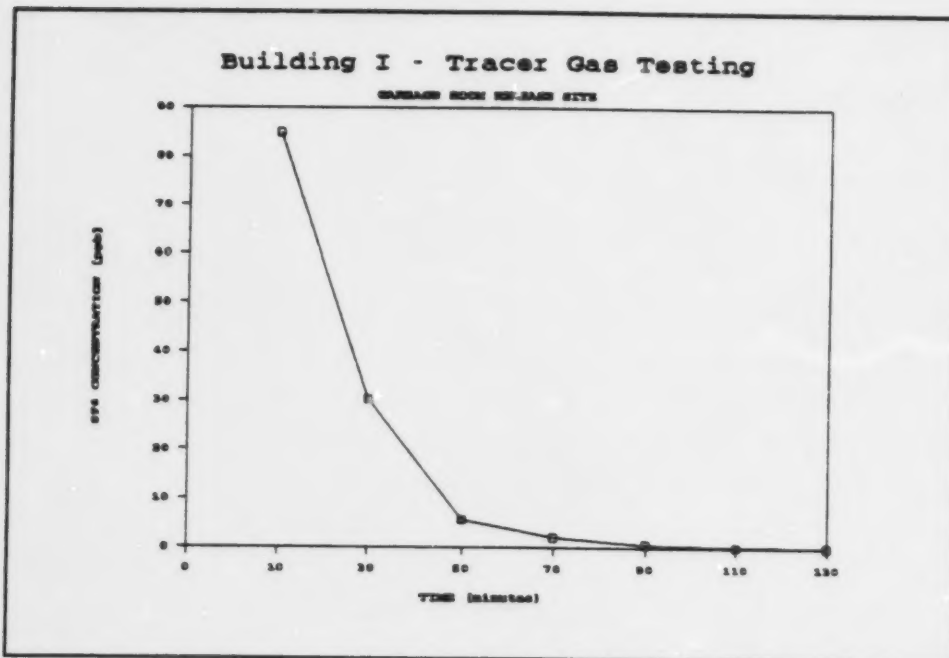
As indicated by Figure 2, the tracer gas concentration at the release site decreased rapidly.

Figure 2: The tracer gas concentration declined rapidly at the release site.

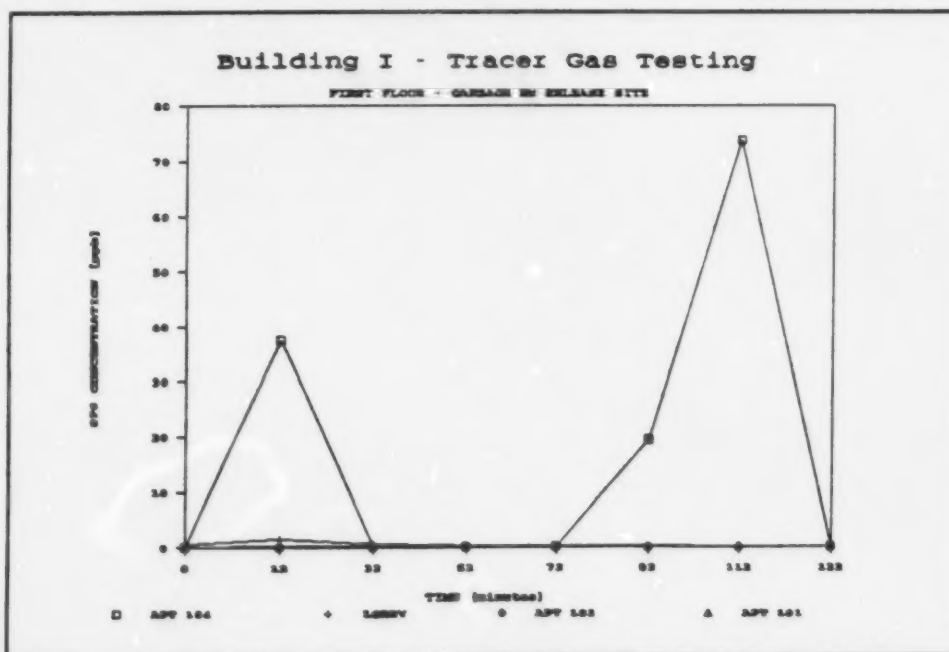
Apartment 104, which is adjacent to the release site on the North-East side of the building, experienced two peaks in concentration. A concentration decline is noted in the thirty two to seventy two minute interval. During this period, it was noted that the apartment occupant was coming and going from the apartment several times. This action of opening and closing doors may have "flushed" the apartment. After this activity ceased, however, the tracer gas concentration again grew at a steady rate and peaked.

The door between the South-East corridor and the lobby was always kept open. During the test, no appreciable concentration of SF₆ gathered in the lobby. This could be due to the fact that the lobby was consistently "flushed" with fresh air as occupants entered into and departed from the building.

The sampling locations on the South-West side of the building were always isolated from the release site by a corridor door which remained closed. These locations experienced a moderate increase and then decrease in SF₆ concentration. The tracer gas concentrations recorded at these locations amounted to only a minute proportion of the concentrations recorded near the release site.

Figure 3: Two peaks in tracer gas concentration occurred at the locations which were in close proximity to the release site. The other locations experienced relatively small concentrations.

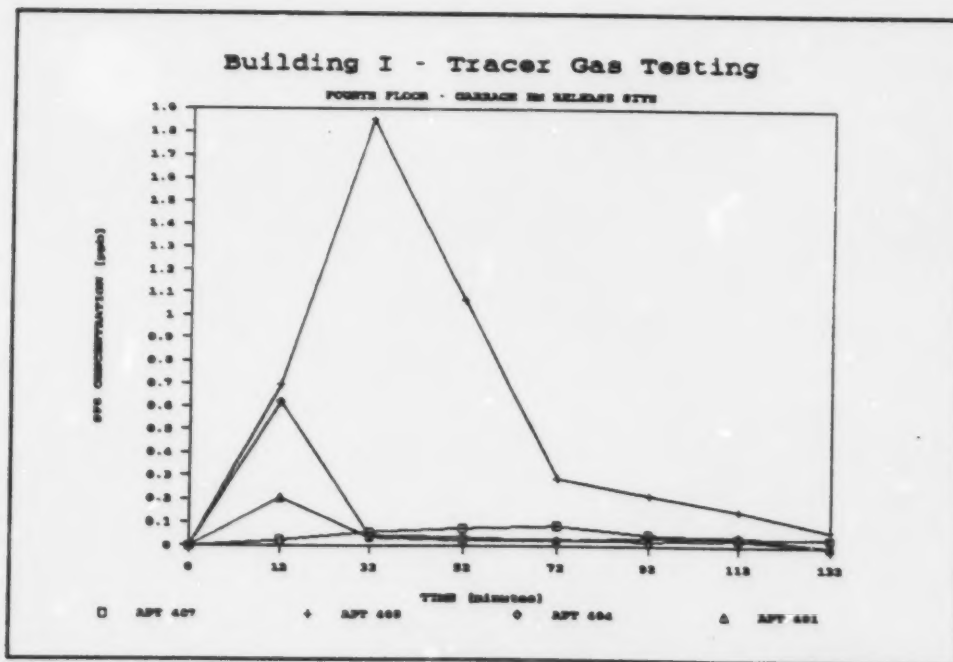
Figure 4 illustrates the tracer gas concentrations logged on the fourth floor. It is evident that each location experienced an increase and then a decrease in tracer gas concentration. Apartment 405, directly over the release site, and which enclosed the garbage chute, showed the greatest peak in concentration.

It is interesting to note that apartment 407, to the North-East of the release site, although closer to the release site than either apartment 401 or apartment 404, showed the minimum tracer gas concentration. It should be noted, however, that apartment 407 did experience a steady increase and then a steady decline in tracer gas concentration.

In comparing the concentrations noted, and the location within the building, it becomes evident that higher gas concentrations were resulting at the leeward sampling locations.

Figure 4: Higher tracer gas concentrations occurred on the leeward side of the building.

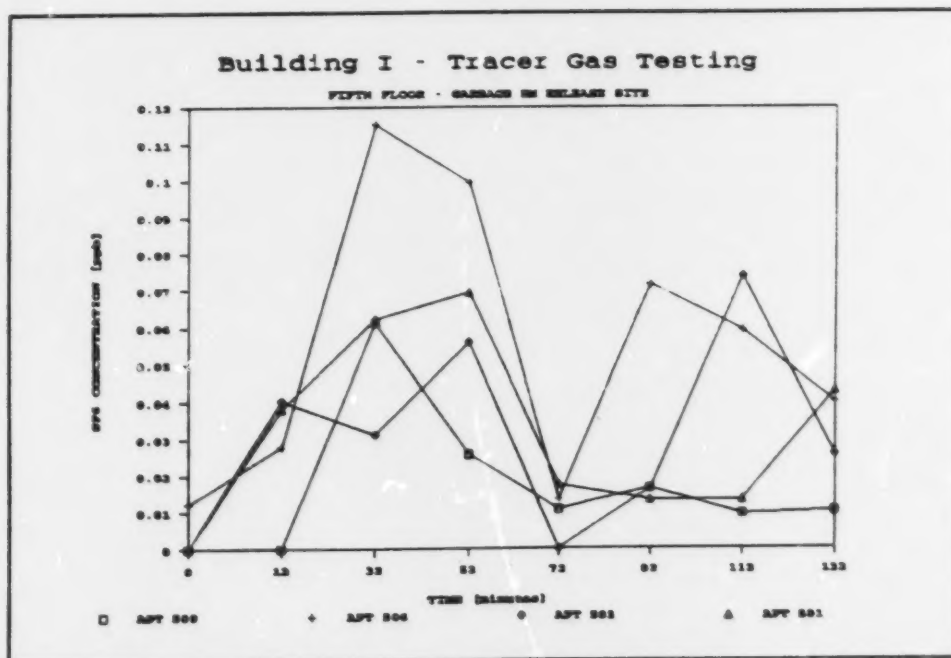
Figure 5 illustrates the tracer gas concentrations logged on the fifth floor. All the concentrations on the fifth floor seemed to peak and then decline and then peak again. The concentration peaks noted are only about one tenth of the peak concentrations noted on the fourth floor.

All the concentrations noted on the fifth floor were comparable to the concentrations encountered in apartments 401 and 407 on the fourth floor.

Figure 5: Concentrations detected here are much smaller than those detected on the fourth floor.

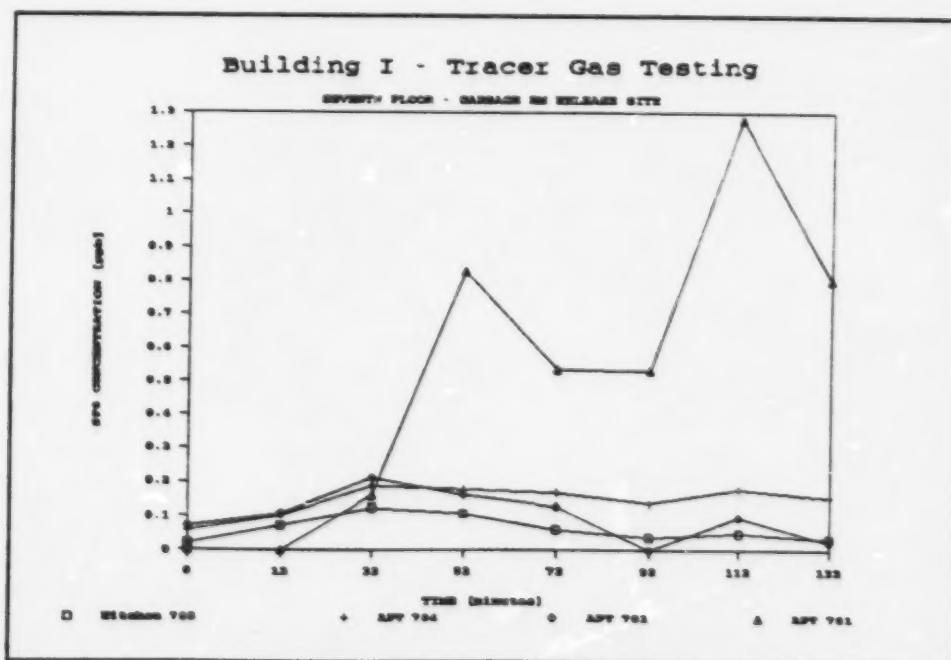
Figure 6 illustrates the tracer gas concentrations logged on the seventh floor. Apartment 701, to the South-West of the release site experienced a dramatic increase in tracer gas concentration while the other locations on the floor maintained relatively consistent tracer gas levels. It should be noted that the concentration peak occurred much later than the peaks encountered on the other test floors.

These findings indicate that the influence of the drafts noted in the kitchen of apartment 705 is minimal when compared to the influence of other factors such as the wind and the stack effect.

Again it is noted that the location where the highest tracer gas concentrations were encountered is on the leeward side of the building.

When the concentrations for each location in the building are correlated with the weather data, it becomes apparent that the air movement is greatly influenced by the wind and outside temperatures. Higher concentrations occur on the upper floors on the leeward side of the building.

Figure 6: The highest concentrations occur on the leeward side of the building.

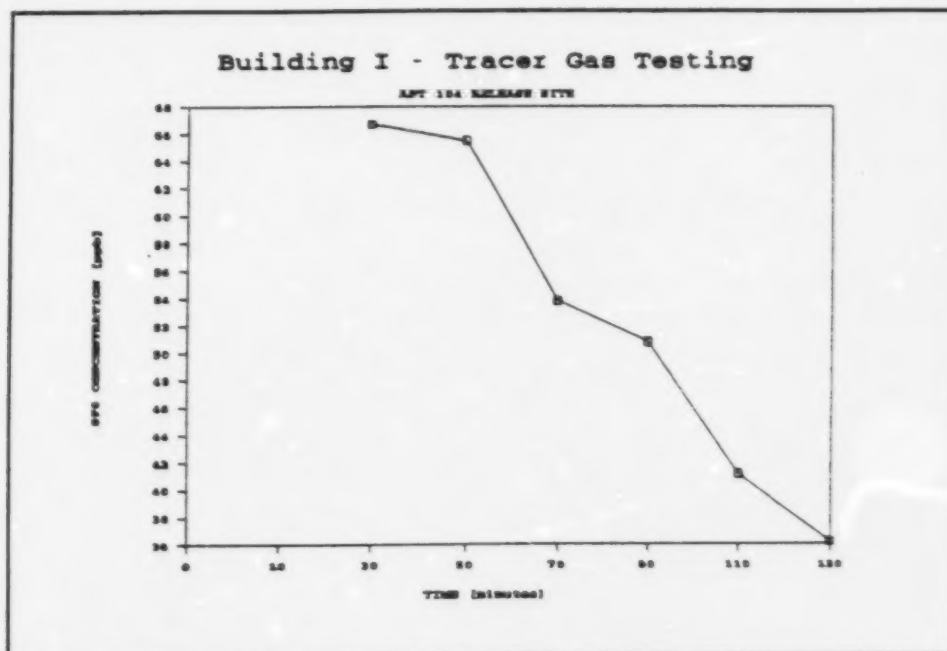
It is interesting to note, as shown in Figure 7, that the tracer gas did not disperse at such a dramatic rate as at the garbage chute. In fact, over the duration of the test (from 10 to 130 minutes after release) the tracer gas concentration only decayed by half.

Figure 7: The decay rate of the tracer gas is much lower here than in the garbage room.

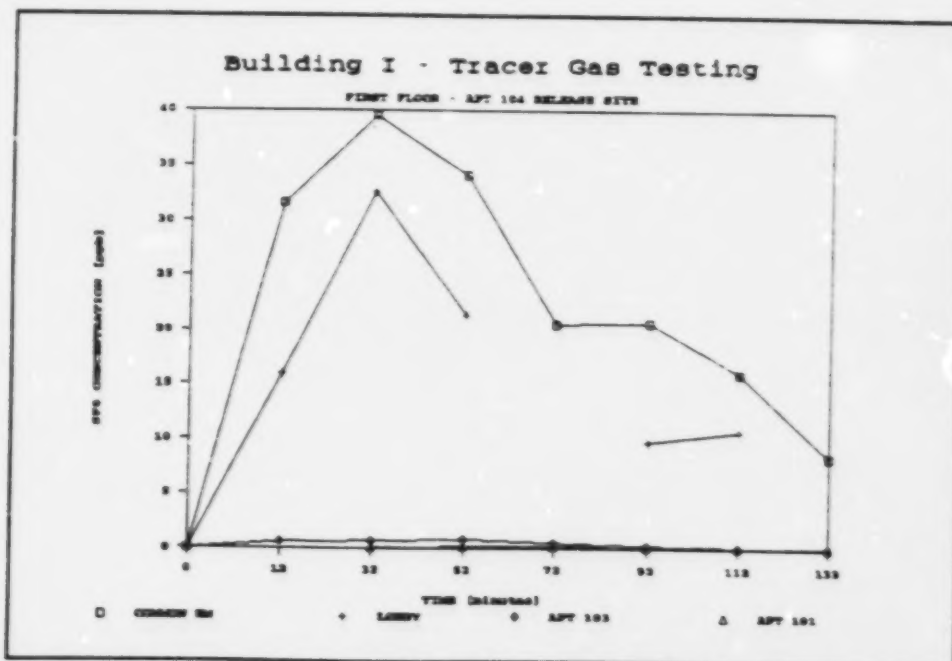
Figure 8 illustrates the tracer gas concentrations logged on the first floor. At the sampling location in the common room, South of the release site, the concentration increased rapidly and then started a gradual decrease. During one interval, the concentration appeared to remain relatively constant. This coincided to a period when the common room door to the lobby was closed.

More weight is added to this assertion when it is noted that the concentration detected in the lobby was also quite high but not as high as the concentration detected in the common room.

The other sampling locations on the first floor experienced concentrations which were relatively low when compared to the common room and lobby. The concentrations were, however, relatively high when compared to the concentrations recorded on the other floors.

Figure 8: The highest concentrations are occur in the common room. The concentration remained constant when the common room door to the lobby remained closed.

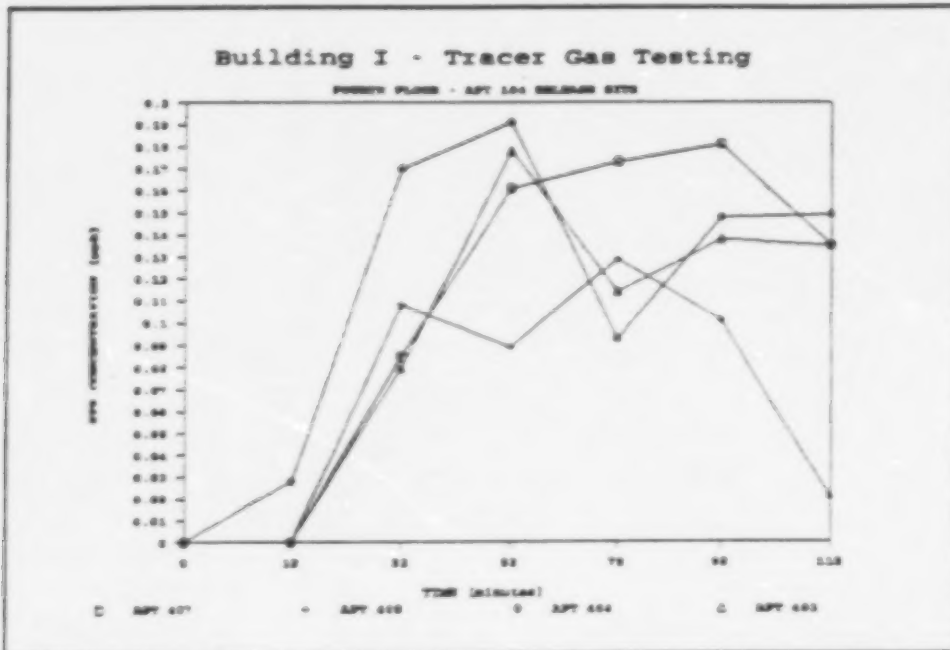
Figure 9 illustrates the tracer gas concentrations logged on the fourth floor. It can be seen that the peaks on the fourth floor occur at a later time than the peaks on the first floor. No particular sampling location dominated over the others for retaining tracer gas concentrations.

Figure 9: There does not appear to be any particular areas of higher tracer gas concentration.

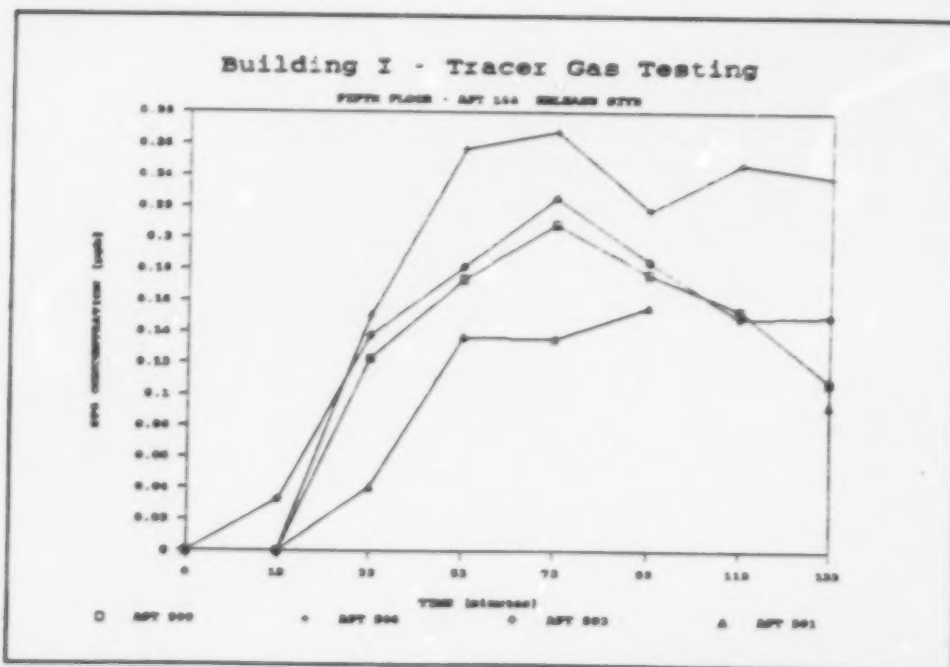
Figure 10 illustrates the tracer gas concentrations logged on the fifth floor. It is notable that the concentration curves here tend to have a steadier climb and fall than they did on the fourth floor. The peak concentration occurred later on the fifth floor than on the fourth floor. In addition the peak concentrations on the fifth were higher than the peak concentrations on the fourth.

Apartment 506 demonstrated the largest concentrations while apartments 503 and 508 experienced concentrations of about the same level. Apartment 501, South-West of the release site, encountered the lowest concentrations.

These observations again correspond to the direction of the wind. The leeward apartment, in this case apartment 506, encountered the highest tracer gas concentration, while the apartment furthest away from the release site on the windward side of the building was bypassed by the higher concentrations.

Figure 10: Higher tracer gas concentrations are encountered on the fifth floor than on the fourth floor.

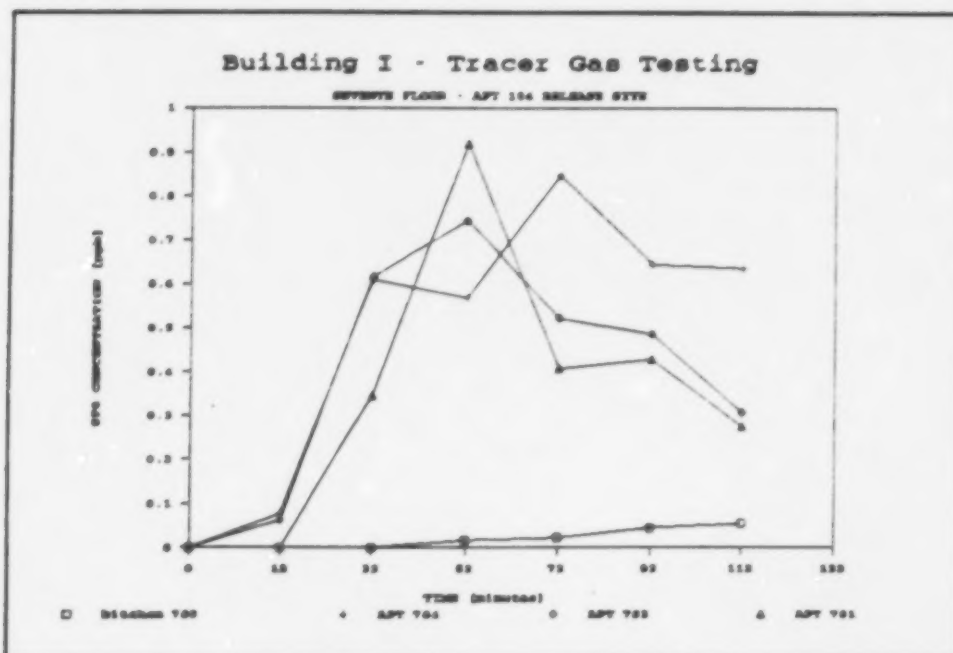
As with the first release site, the concentrations observed in the kitchen of apartment 705 is very small when compared to the other concentrations on the floor.

It is interesting to note that the concentrations peaked earlier on the seventh floor than on the fifth floor however the seventh floor peaks are of much greater magnitude than the peaks encountered on the fifth floor.

Although apartment 701 experienced the highest concentration peak, it also experienced a rapid decline. Apartments 703 and 704 both experienced higher average tracer gas concentrations. Apartment 704 gained a higher concentration peak than 703, but it peaked at a later time.

Figure 11: Tracer gas concentrations here are much higher than concentrations on the middle floors. In addition, the leeward apartments maintain higher concentrations than the windward apartments.

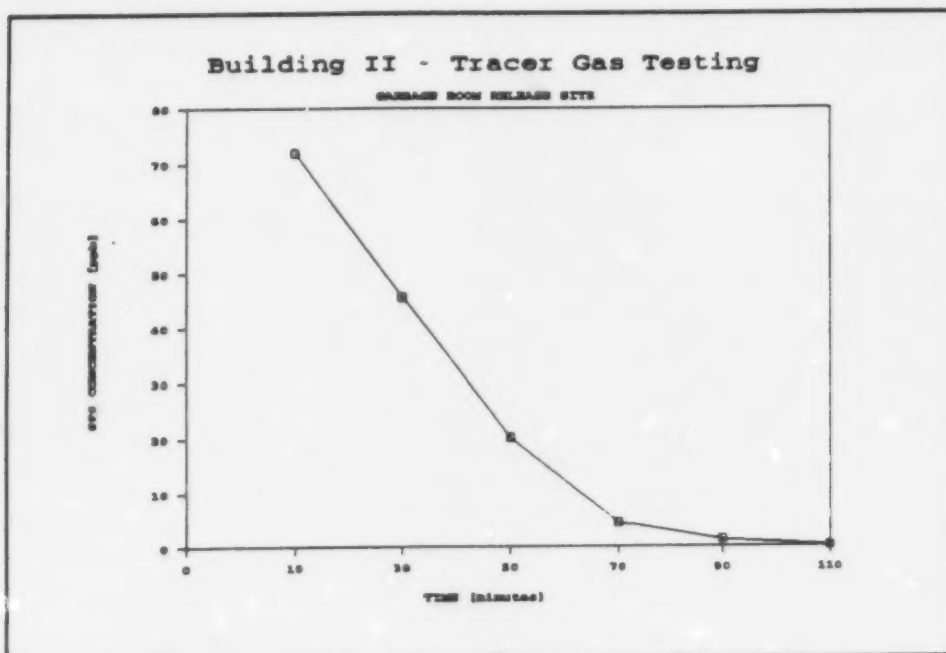
As shown in Figure 13, the tracer gas concentration decreased rapidly at the release site.

Figure 13: Tracer gas concentration decreases rapidly.

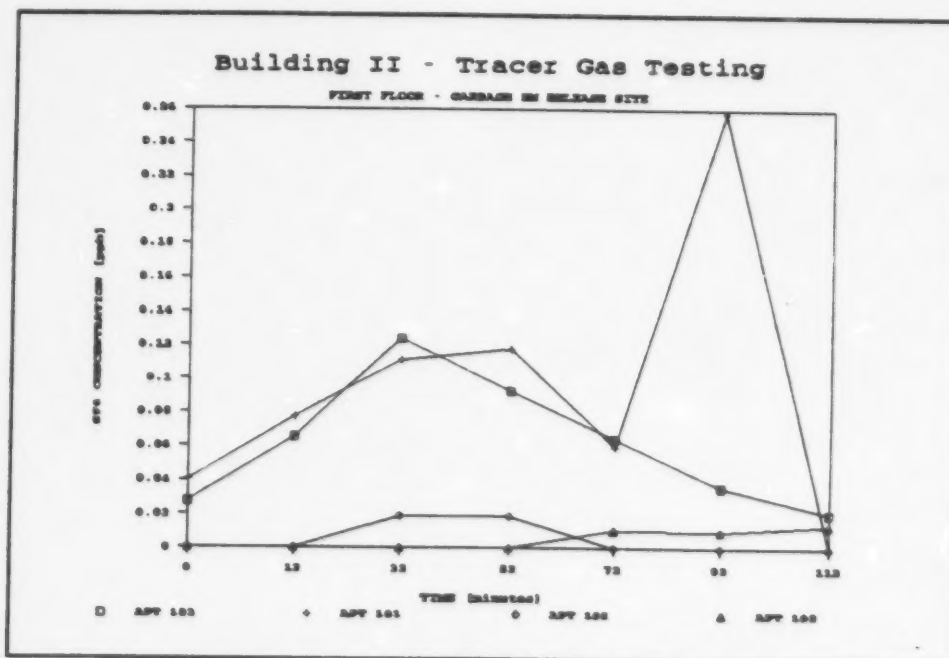
Figure 14 illustrates the trends in tracer gas concentration noted on the first floor. Those locations which were over the half basement showed substantially larger concentrations than those locations which were isolated from the half basement.

Apartment 108 only showed trace amounts of tracer gas during the latter portion of test. Apartment 105 only had detectable tracer gas concentrations during 30 to 50 minute period during the test. Both of these apartments are separated from the garbage chute by corridor doors.

Apartment 101, which is directly above the garbage room and adjacent to the garbage chute recorded the greatest tracer gas concentrations. Apartment 103, which is West of the release site, peaked quickly and then experienced a steady decline in tracer gas concentration.

Figure 14: The sampling location beside the garbage chute experienced the greatest peak in tracer gas concentration.

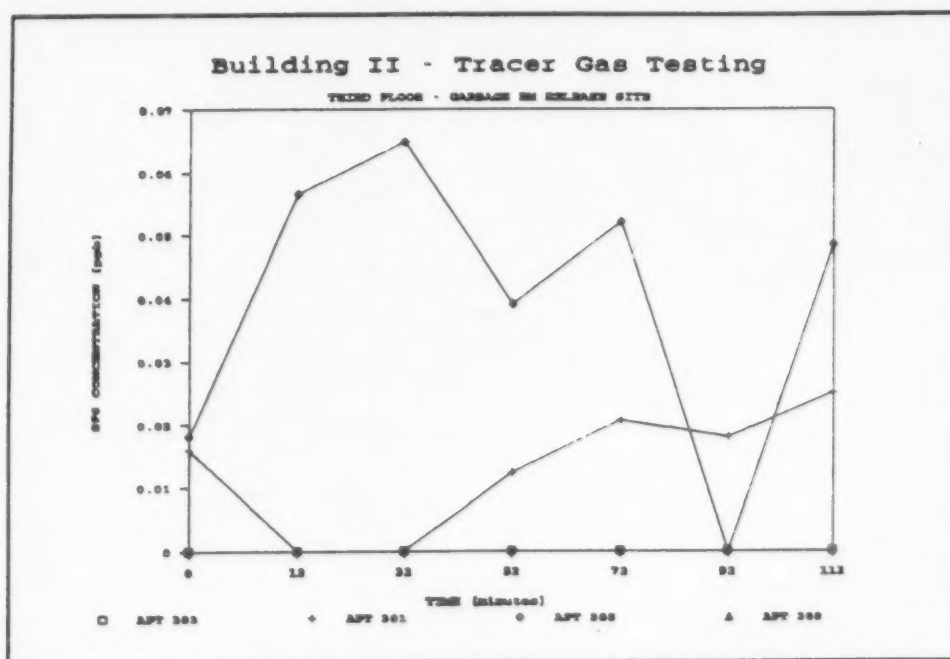
Apartments 303 and 308 showed no traces of SF_6 at all. Apartment 305, West and across the hall from the garbage chute, recorded the largest concentration.

During the second time interval the garbage chute door was opened. During the same period the concentration recorded for apartment 301 went to zero, and the concentration reported for apartment 305 increased substantially. Once the door was closed again, the concentration reported for 305 decreased again and the concentration recorded for apartment 301 rose again. This result may be due to wind blowing through the corridor window, across the hall and into apartment 305

Figure 15: Only the two apartments on the same side of the building as the release site had detectable tracer gas concentrations.

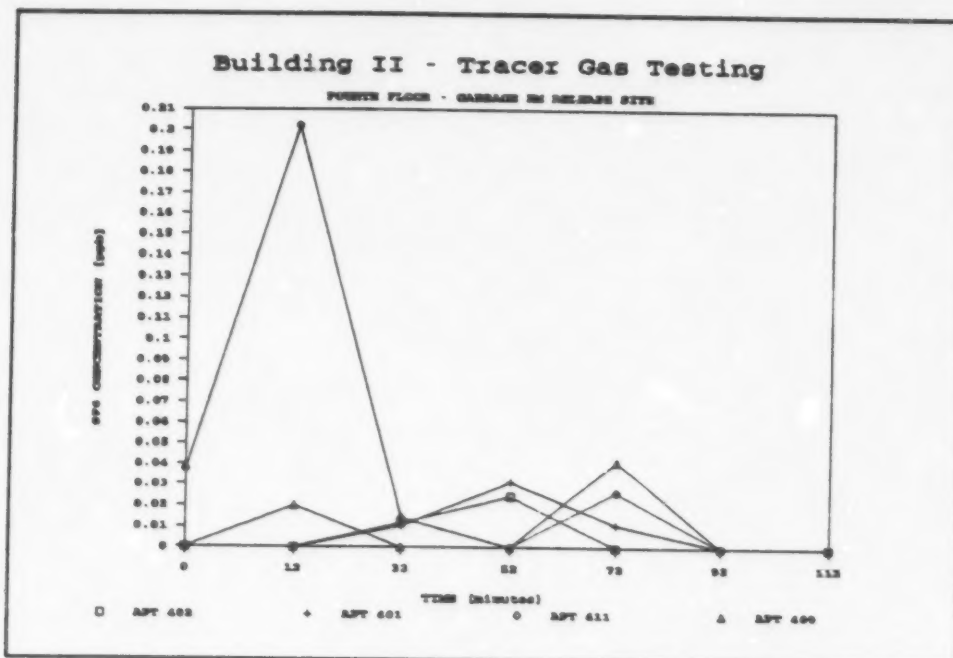
Figure 16 illustrates the trends in tracer gas concentration noted on the fourth floor. The concentrations noted in apartment 411, North-West of the garbage chute, experienced a very rapid increase and then decline. The concentrations recorded for the other apartments seemed to fluctuate substantially with no discernable trends being noted.

Figure 16: Apart from the initial increase in tracer gas concentration in apartment 411, no discernable trends in the concentration data is noted.

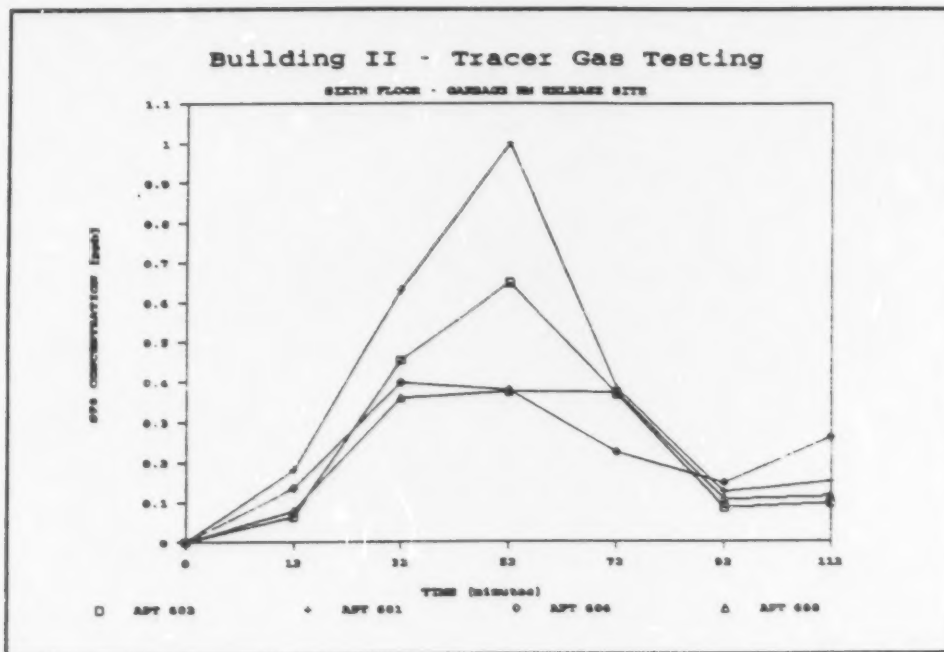
Figure 17 provides a clear example of concentrations increasing and then decreasing. Apartment 601, adjacent to the garbage chute peaked with the highest concentration. Apartment 602 encountered the next highest concentration and apartments 608 and 606 concentrations were very close.

The concentrations recorded on this floor were higher than any of the concentrations recorded on the other floors. This indicates that the stack effect is still having an influence on the air flow in the building. It is apparent, however, there is little correspondence between high concentrations and wind direction.

Figure 17: The tracer gas concentrations detected on this floor are greater than the concentrations detected on any of the other floors.

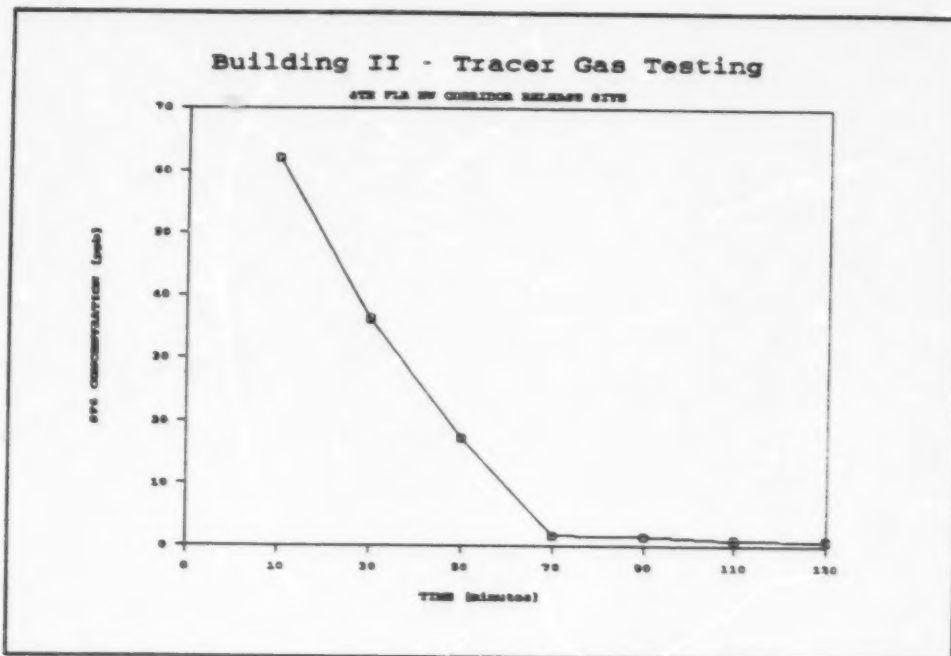
As shown in Figure 18, the tracer gas concentration decreased more rapidly at this release site than in the garbage room.

None of the samples taken from sampling locations below the fourth floor contained detectable concentrations of gas.

Figure 18: The tracer gas dissipated more rapidly here than in the garbage room.

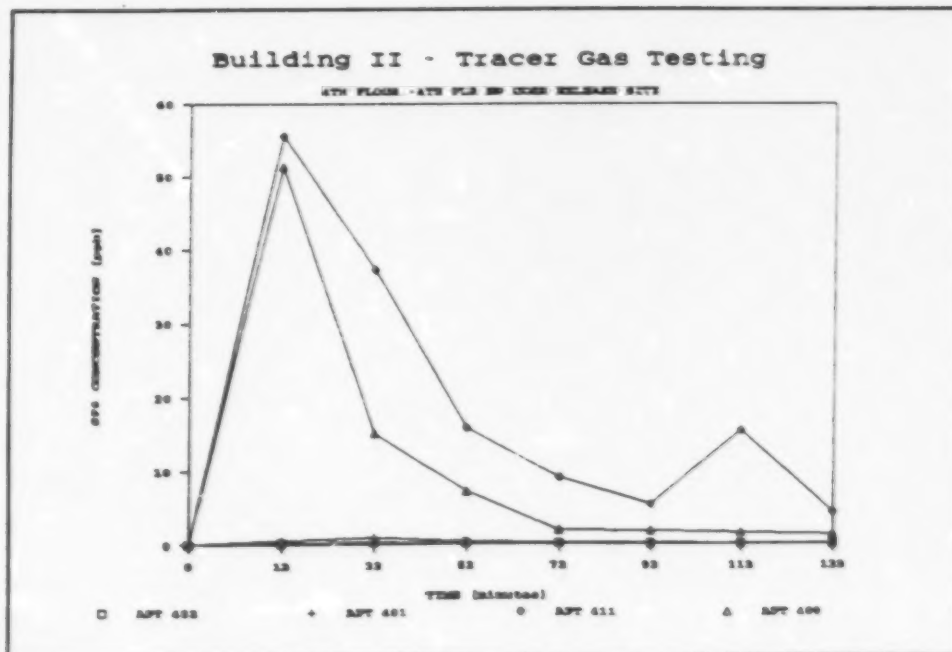
As shown in Figure 19, those apartments on the same side of the building as the release site had very large concentrations of tracer gas while those apartments on the other side of the building, separated by corridor doors, only had small amounts of the tracer gas.

The rapid decline in tracer gas concentration indicates a rapid dissipation rate. It is noted, however, that apartment 411 had a second increase in concentration during the latter portion of the test. This corresponded to elevator activity which was occurring at the time.

Although much smaller than the other concentrations which were detected, the concentrations detected in apartments 401 and 402 peaked early and then declined steadily.

Figure 19: The rapid dissipation of the tracer gas from the corridor release site is echoed by the rapid increase and then decrease in tracer gas concentration in the neighbouring apartments.

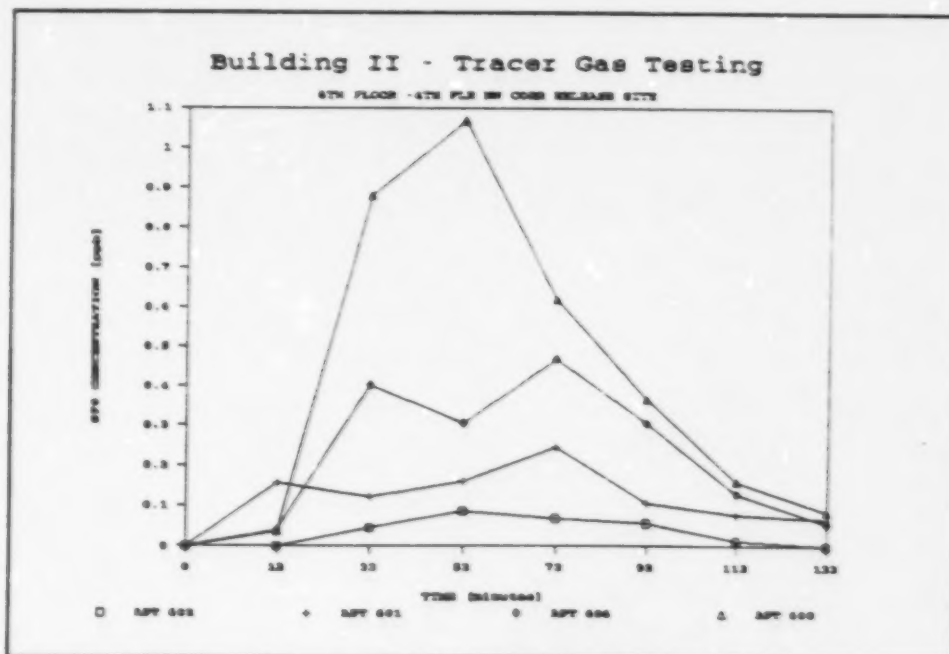
As shown in Figure 20, the concentrations detected on the sixth floor are of the same magnitude detected in apartments 401 and 402. Again the apartments on the opposite side of the building from the release site experience a lower concentration rate.

Apartment 602 recorded the lowest concentration levels but did experience a rise to a peak and then experienced a steady decline.

There are a great number of fluctuations in the data for the sixth floor. These fluctuations correspond to the activity which was occurring on the floor at the time of the test.

Figure 20: The apartments on the same side of the building as the release site experience the greatest increase in tracer gas concentration.

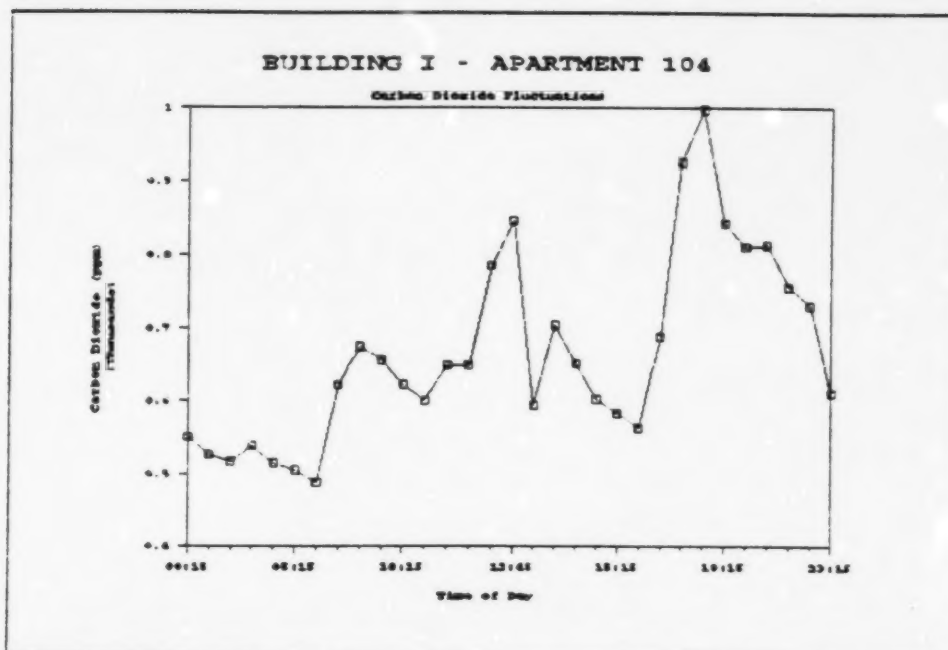
Figure 1: Peak concentrations occur when the parking garage would be busy and at night when the apartment would be occupied for longer periods of time.

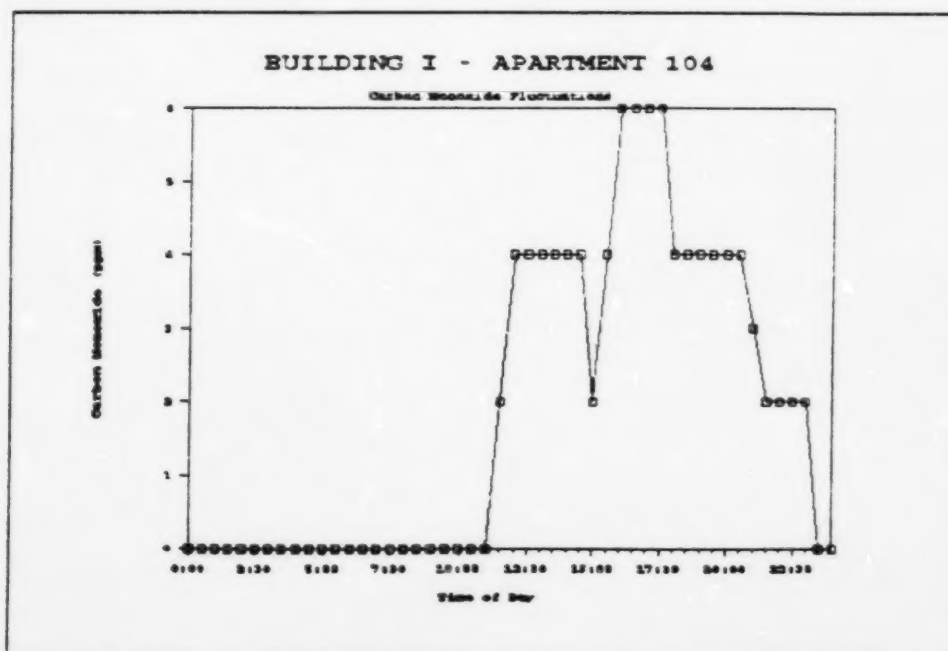
Figure 2: Peak Carbon Monoxide concentrations occur when the parking garage is busy.
